United Kingdom Civil Aviation Authority	MPD No: 2010-008 Issue Date: 17 September 2010
<h2 style="text-align: center;">EMERGENCY MANDATORY PERMIT DIRECTIVE</h2>		
<p>In accordance with Article 22(1) of the Air Navigation Order 2009 as amended the following action required by this Mandatory Permit Directive (MPD) is mandatory for applicable aircraft registered in the United Kingdom operating on a UK CAA Permit to Fly.</p>		
MPD: 2010-008 ROTORSport UK		
Subject:	Rotor Blade Cracks	
Applicability:	All Rotorsport UK Ltd. MT03 and MTOSport gyroplanes.	
Reason:	<p>CAA has been advised that cracks have been found in the rotor blades (Aircraft type) of a Rotorsport UK Ltd MT03 gyroplane. Further investigation by Rotorsport UK Ltd. has found cracks on non-UK registered MT03 and MTOSport gyroplanes fitted with both Aircraft and Autogyro type rotor blades. The cause of the cracking is still under investigation.</p> <p>Cracks in the rotor blades may result in loss of a rotor blade and consequent loss of a gyroplane.</p>

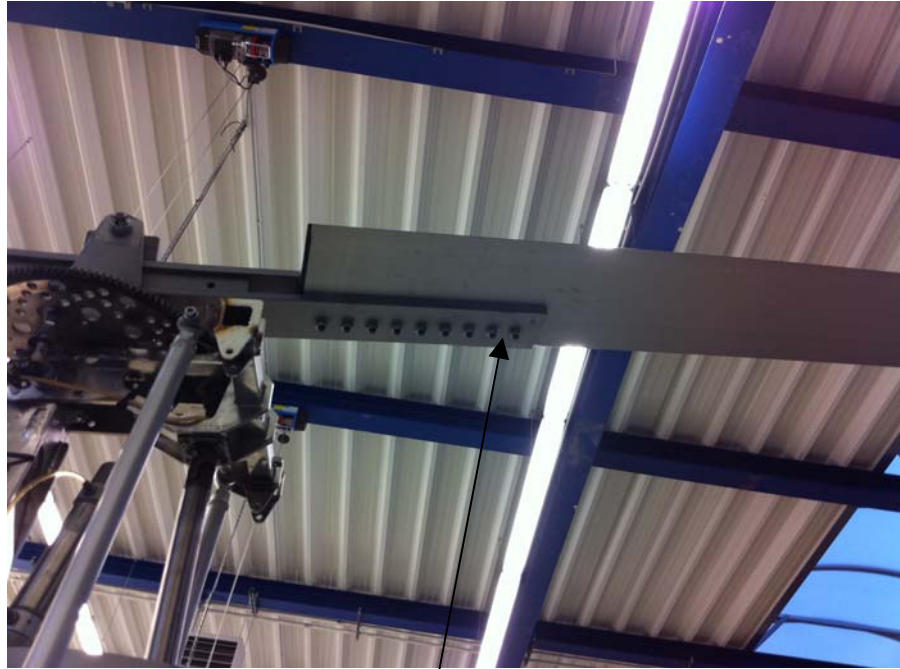
- 5) If the inspection under item 1) is unable to be carried out at the current location of the gyroplane, a single ferry flight from the current location of the gyroplane to the maintenance facility for the inspection under this MPD only may be carried out. The gyroplane must be flown solo for this ferry flight and the flight must be preceded by a visual inspection of the area in question (see photograph below) by the pilot:

area to be inspected (SB034 Issue 2)

Compliance:	<ol style="list-style-type: none"> 1) Before further flight, from the effective date of this MPD, visually inspect each rotor blade for cracks in accordance with the instructions of Rotorsport UK Ltd. Service Bulletin 034 Issue 2. 2) If cracks are found as a result of the inspection under 1), both rotor blades are to be replaced with new parts. 3) If cracks are not found as a result of the inspection under 1) the gyroplane may be returned to service. 4) Report any cracked blades found to Rotorsport UK Ltd. at the address on the next page, and to Aircraft Certification Department 2E, United Kingdom Civil Aviation Authority, Safety Regulation Group, Aviation House, Gatwick Airport South, West Sussex, RH6 0YR.
