## AIRCRAFT ACCIDENT REPORT AND EXECUTIVE SUMMARY

Reference:	CA18/2/3/8573	
<b>Aircraft Registration</b>	<b>ZU-ETU</b>	<b>Date of Accident</b>	30 October 2008		<b>Time of Accident</b>	0830Z
<b>Type of Aircraft</b>	Sanka AK 1-3 (helicopter)		<b>Type of Operation</b>		Private	
<b>Pilot-in-command Licence Type</b>		Private Pilot	<b>Age</b>	40	<b>Licence Valid</b>	Yes
<b>Pilot-in-command Flying Experience</b>		Total Flying Hours	127.8		Hours on Type	83.2
<b>Last point of departure</b>		Nelspruit private heliport.				
<b>Next point of intended landing</b>		Nkorho Bush Lodge.				
<b>Location of the accident site with reference to easily defined geographical points (GPS readings if possible)</b>						
Sabi Sands Game Reserve						
<b>Meteorological Information</b>		Wind: 010°/±5 kts, Temperature: 28°C, Visibility: Good.				
<b>Number of people on board</b>	1 + 0	<b>No. of people injured</b>	0	<b>No. of people killed</b>	0	
<b>Synopsis</b>						
<p>The pilot flew the helicopter on a visual flight rules (VFR) private flight in daylight conditions from the Nelspruit private heliport to Nkorho Bush Lodge at Sabi Sands. The duration of the flight was approximately 0.7 hours, when the pilot su

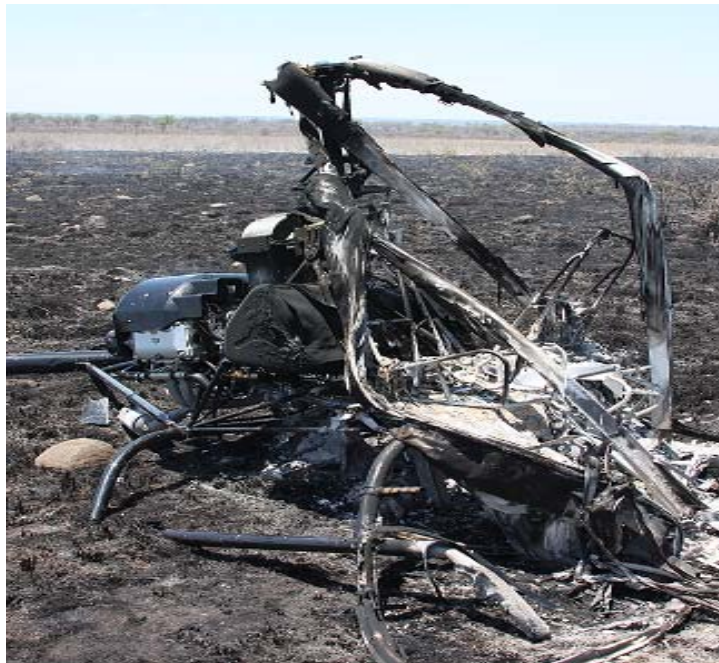
- 1.3.1 The helicopter was destroyed by an ensuing fire that was initiated by hot gasses that set the grass alight.

Photo1: Shows the fire damage caused to the helicopter.

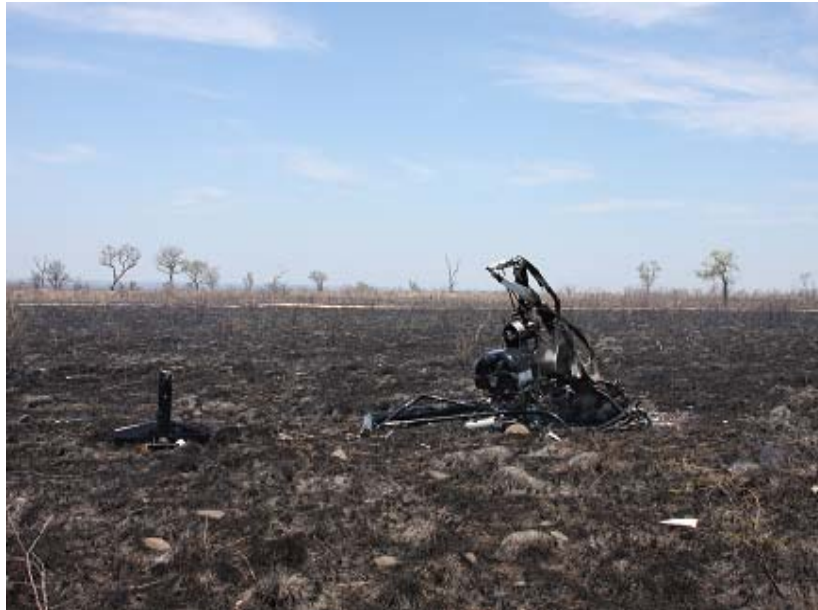
1.12.1 The helicopter was landed successfully on an open grass covered flat area without sustaining any impact damage and was still intact. A veldt fire was subsequently ignited by the hot gasses from the engine exhaust which also caused the helicopter to catch alight. The helicopter was then destroyed by the fire. (See photo below)

Photo 2 Helicopter destroyed by grass fire.

1.14.1 The pilot reported that the fire started after landing the helicopter and that the origin of the fire was the dry grass ignited by the exhaust gasses. The combination of helicopter plastic and fabric material, fuel carried on board and dry grass became a fuel source for the fire and the fire burned until the helicopter was destroyed. Due to the location of the accident site, there were no rescue fire services available to extinguish the fire. The pilot attempted to extinguish the fire with the portable fire extinguisher carried on board the helicopter. However, when he attempted to use it, he found it to be unserviceable.

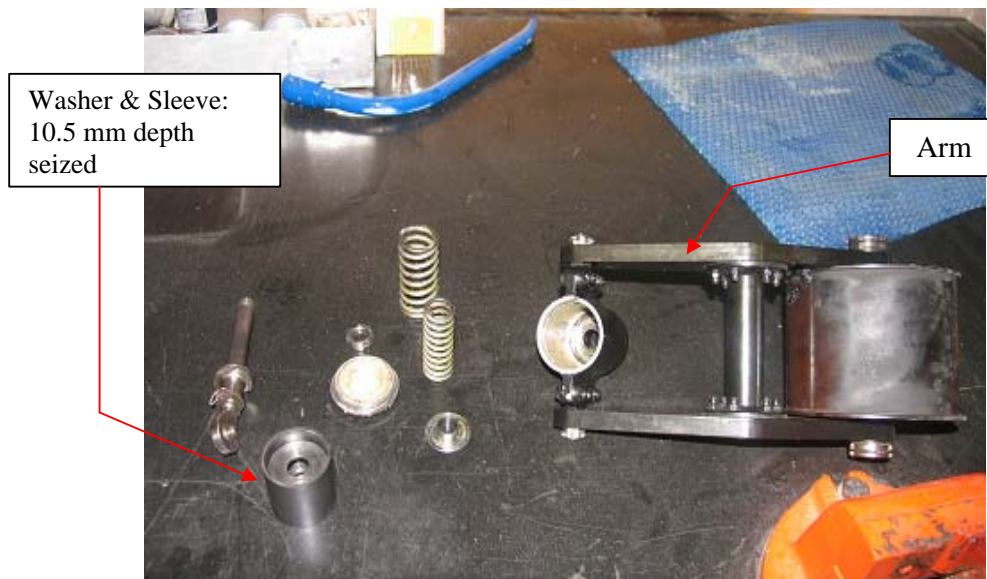
1.16.1 The Idler Actuator operating rod was found moving freely in and out of the casing and not in accordance with the manufacturer's specification. Due to the identified operating defect, the Idler Actuator was disassembled. The following evidence was found:

Photo 3 shows the disassembled Idler Actuator

- (i) During the disassembly process, it was found that the Washer P/N: 04020400012 had seized approximately 10.5 mm into the Sleeve P/N: 0402040008. According to the Parts Catalogue of the helicopter, there should be three rubber Rings P/N: 036-039-19 installed on the washer. The rings may have perished for some reason, because there was only remaining fibre material left which was trapped between the two moving parts, thus causing the washer to eventually seize inside the sleeve.
- (ii) In order to verify the finding, the owners of two other helicopters (ZU-LAC and ZU-RIT) of the same type were requested to remove and also disassemble the idler actuators installed to their helicopters. There were similar findings, which identified serious concerns about the operation of the helicopter.

- (ii) The manufacturer's comments in this regard were that the Idler Actuator seized due to decay or reduction in the fluorocarbon compound bushes inside the casing, which resulted from the heat effect of the fire. The manufacturer may be correct, but they could not explain the scouring/rubbing marks that were found on the inside of the casing. The presence of these markings is a clear indication that for some reason during the operation, the moving parts (washer and sleeve) clearance became restricted and this is probably why the ring on the washer was severely damaged.

- (iii) However, indications are that the damage was not caused by the fire. The damage was clearly caused due to moving parts being subjected to operation in a very tight fit installation. This then also explained the reason for the subsequent modifications and machining down of the different parts of the Idler Actuators.

- (iii) However, subsequent to the seizure of the tensioning device, the manufacturer carried out modifications on all the helicopters, to eliminate the possibility of the problem recurring on the Idler Pulley Tension device. There were measurements taken and the evidence found indicated that the tight fit of the washer in the sleeve was causing scouring marks on the inside. The manufacturer then machined the items as follows:
  - (a) The operating rod shaft was machined and reduced by 0.10 mm to 13.90 mm diameter.
  - (b) The piston washer was reduced by 0.10 mm to 39.89 mm diameter.
  - (c) The end washer internal diameter hole was increased from 14.02 mm to 14.20 mm.
- (iv) To address the issue of the engine speed governor, the manufacturer immediately gave written instructions in a letter to all the owners that further use of the governor system in flight is prohibited.
