A**RALLYE**

N° 120

CR 27-13

SUBJECT : Location of the rudder control on the rudder pedals.
Replacement of the rod nut by a guide nut.

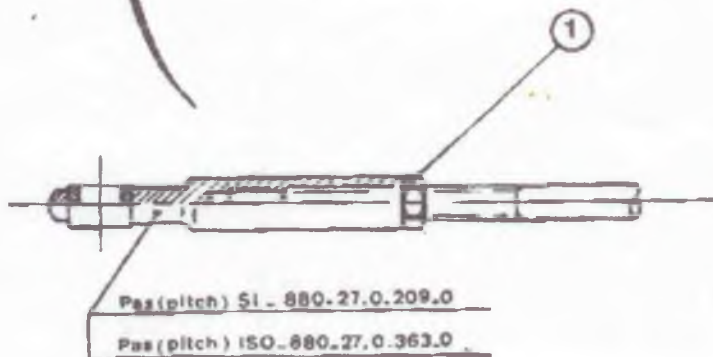
AVANT
(BEFORE)

On the other hand, at the time of overhaul or maintenance operations, some unusual manoeuvres can create abnormal buckling stresses on the rods (for example : the manoeuvre which would consist in pulling one rudder pedal while the other is maintained unmoved). This buckling may, in borderline cases, cause the failure of the rod in its threaded area, behind the eye bolt which ensures the attachment with the rudder pedal. A few similar incidents having occur, we have provided a safety device which consists in replacing the nut, item 1, by a guide nut, item 2. (see figure on page 2/3). This guide nut which has an important length and is bored at its ends, forms a bushing which is engaged both on the eye bolt tail (previously undercut) and on the plain length of the rod. This prevents any bending in this area.
