Parker Hannifin Corporation

# PRODUCT REFERENCE MEMO

## EXTERNAL CALIPER BRAKE ASSY – PISTON ORIENTATION – INSPECT/CORRECT

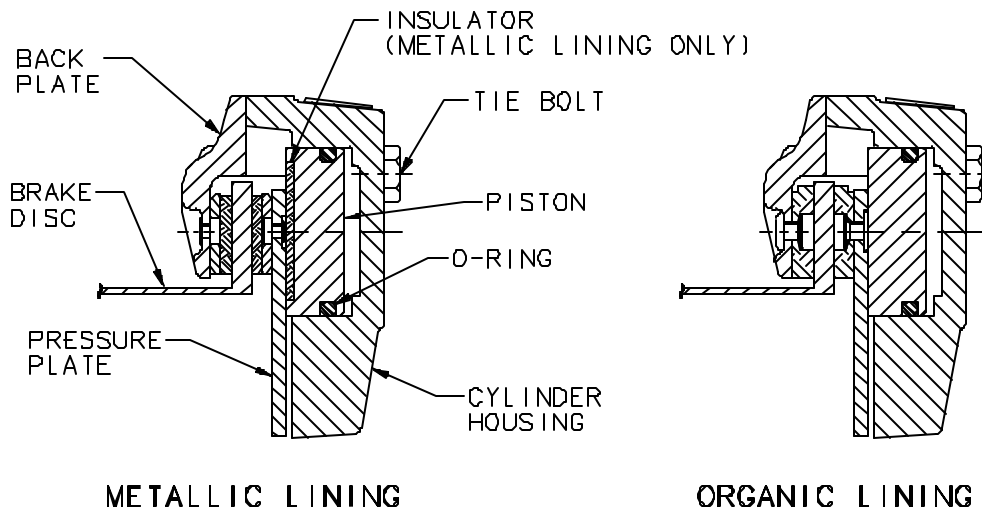
**REASON:** Informational- Parker Hannifin has received a report of a P/N 30-9 brake assembly with the piston installed backwards. The piston o-ring is located closer to one end of the piston than the other. That end is to be inserted towards the bottom of the cylinder piston bore cavity. Proper installation provides adequate engagement of the o-ring to cylinder bore for minimum lining and disc wear conditions. A brake caliper with an incorrectly installed piston may leak hydraulic fluid from around the piston prior to the linings and discs reaching their minimum thickness replacement limits.

Continued use of any brake caliper with an incorrectly installed piston can result in loss of brake effectiveness or directional control of the aircraft.

**FIGURE 1- CROSS-SECTIONAL VIEW SHOWING CORRECT PISTON ORIENTATION FOR BRAKE ASSEMBLIES WITH METALLIC OR ORGANIC LINING**

1. With back plate properly installed, inject low air pressure into the brake fluid port to push the piston out to expose 1/8 to 3/16 of an inch. If you don't see the o-ring, then the o-ring groove is correctly positioned on the inner side of the piston and no further action is required.
2. If the o-ring is visible then disassemble, inspect and reinstall piston with proper orientation in accordance with the Figure 1 above and AWBCMM0001 Component Maintenance Manual (available from Web site: [www.parker.com/cleveland](http://www.parker.com/cleveland)) prior to installation on the aircraft.

1. Loosen back plate tie bolts 3 to 4 complete turns. Do not remove back plate. Apply slight brake pressure at the pedals as needed to move the piston. The piston will extend and be visible between the cylinder housing and the pressure plate. You may need an assistant to inspect the piston while you are applying brake pressure.

2. If the o-ring is visible after 1/8 to 3/16 of an inch of piston travel then the piston is installed incorrectly. Disassemble, inspect and replace any worn components. After inspection, reassemble and test in accordance with the AWBCMM0001 Component Maintenance Manual. Make appropriate log book maintenance entry.

3. If the o-ring is not visible after 1/8 to 3/16 of an inch of piston travel and no fluid leakage is observed, the piston is installed correctly. Re-torque the tie bolts to value specified for your specific brake assembly in accordance with the AWBCMM0001 Component Maintenance Manual (available from Web site: [www.parker.com/cleveland](http://www.parker.com/cleveland)).
