# SERVICE BULLETIN

## POSSIBLE DEVELOPMENT OF CIRCUMFERENTIAL CRACKS IN CLEVELAND BRAKE DISCS USED ON CERTAIN MODELS OF THE PIPER PA-31 NAVAJO AIRCRAFT

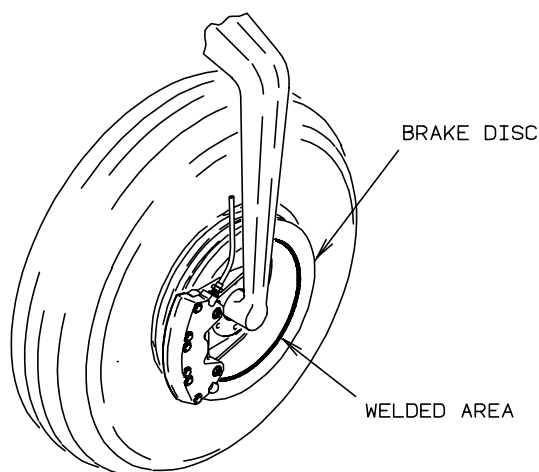
Sketch #1

**PURPOSE:** To inspect the welded area of the brake disc for circumferential cracks. Affected brake disc assemblies are:

Visually inspect the welded area (see Sketch #1) for evidence of circumferential cracks. This type of crack will split the paint and is readily visible to the naked eye. If cracks are found, replace with a new brake disc of the corresponding part number.

**INSTRUCTIONS:** Within the next 25 hours, or at the next scheduled maintenance inspection, whichever occurs first, perform the following inspection:

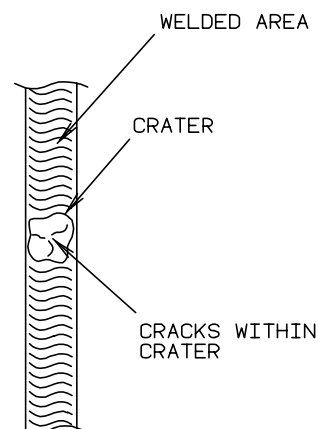
Sketch #2

**NOTE:** A slight impression, or crater, may be found in the weld bead (see Sketch #2). This crater is caused by electrode removal at the end of the welding cycle. Small cracks contained within this crater are not detrimental and does not necessitate brake disc replacement.
