SERVICE BULLETIN

POSSIBLE DEVELOPMENT OF CIRCUMFERENTIAL CRACKS IN THE WELD ON PART NUMBER 164-06100 BRAKE DISC ASSEMBLY USED IN HEAVY-DUTY WHEEL AND BRAKE INSTALLATION ON BEECH BARON AIRCRAFT

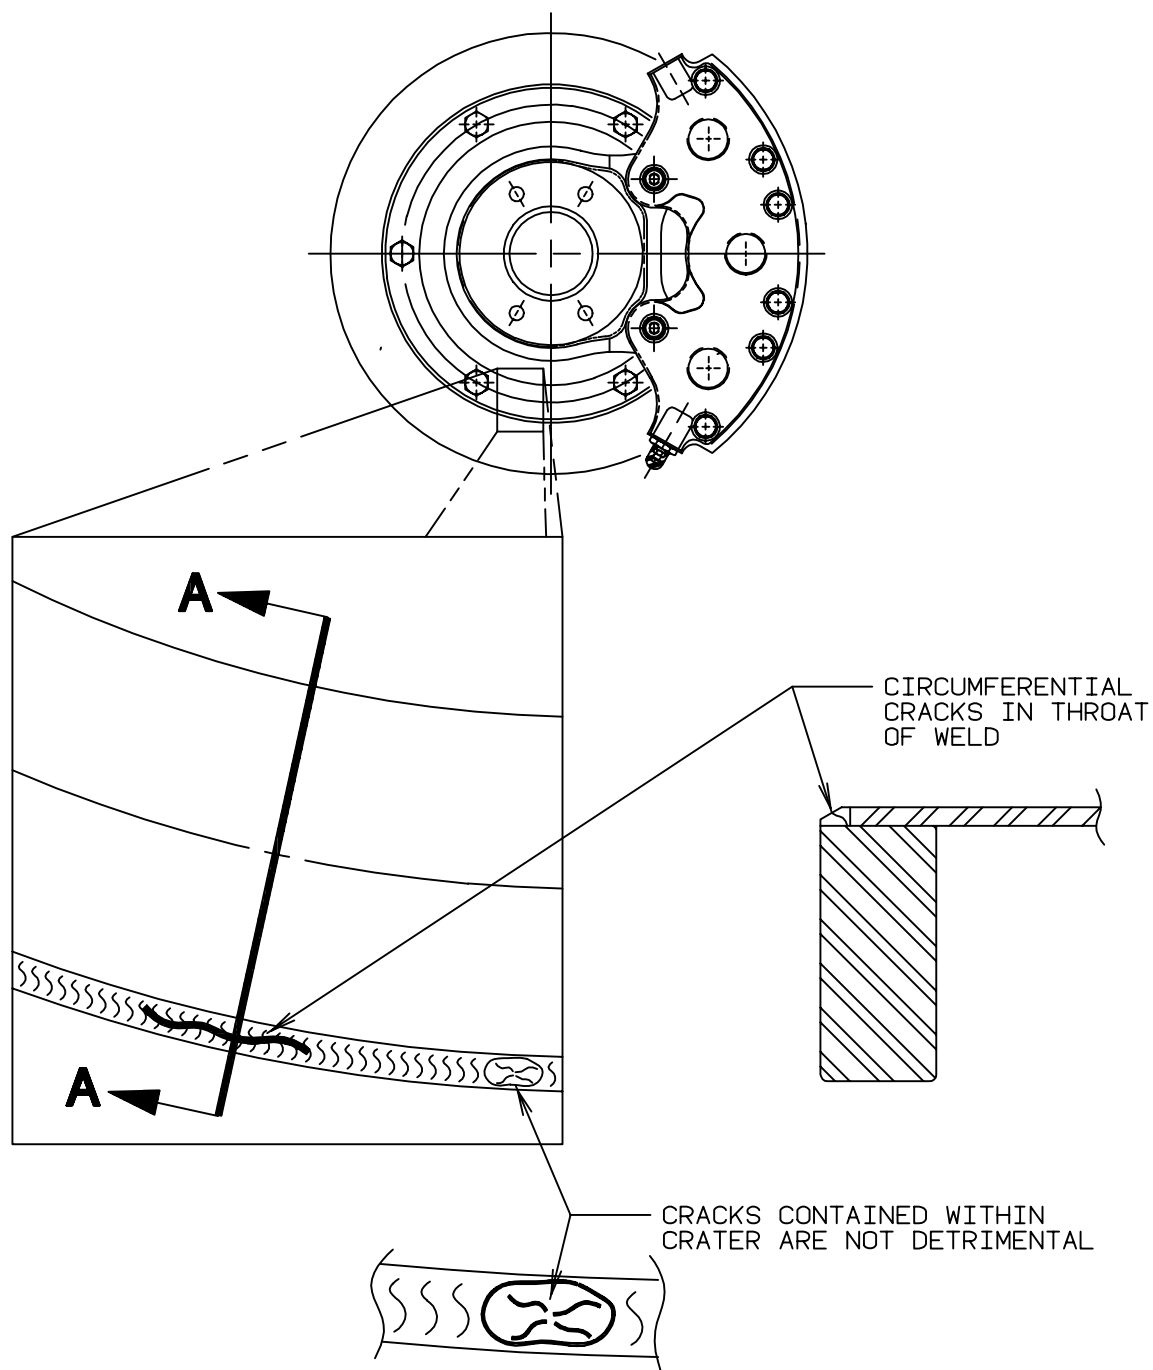
Visual Inspection Reference Sheet

- a. Perform three (3) consecutive brake stops (no cooling) from 50-60 mph using a 9-10 second stop time requirement to decelerate the aircraft from initial speed to 0 mph.
- b. After completion of these three stops, visually inspect the periphery of the weld for circumferential cracks. This type of crack will split the paint and is readily visible to the naked eye.

NOTE: On the weld surface, a circular indentation, commonly referred to as the weld crater, will be found. This crater is the result of electrode removal at the end of the welding cycle. This crater, and/or cracks contained within this crater are not detrimental to the function or service life of the disc.

- c. If, after completion of the evaluation stops and inspection of the weld, there are no cracks present, no further procedures are required.
- d. If circumferential cracks of any magnitude are found in the weld during inspection, the affected brake disc assembly must be replaced with an assembly of corresponding part number (164-06100). After replacement of the affected disc, the aircraft may enter normal service without further evaluation or inspection.
