SERVICE BULLETIN

POSSIBLE DEVELOPMENT OF CIRCUMFERENTIAL CRACKS IN CLEVELAND BRAKE DISCS USED ON PIPER AIRCRAFT

PURPOSE: To inspect the welded area of the brake disc for circumferential cracks. Affected brake disc assembly: P/N 164-05000 used in wheel assembly 40-124.

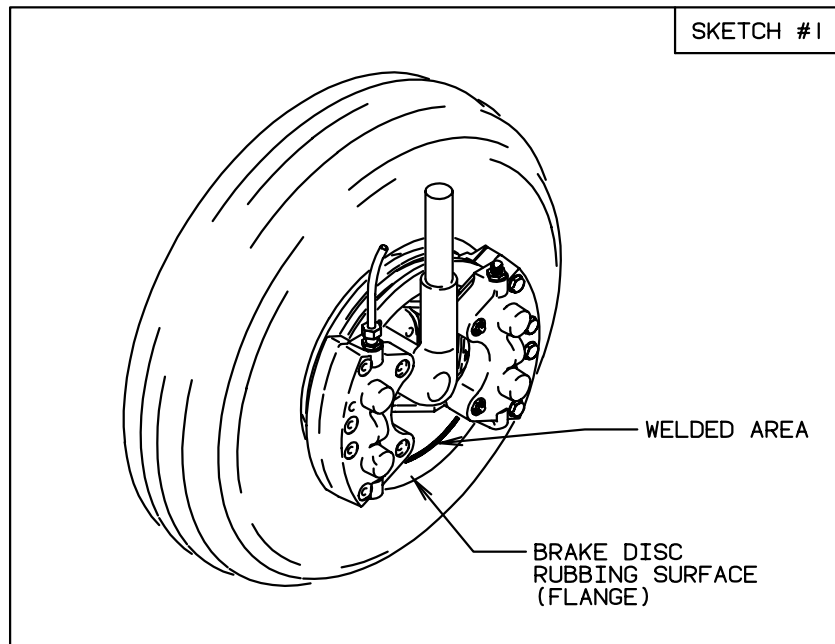
1. Visually inspect the welded area (see Sketch #1) for evidence of circumferential cracks. This type of crack will split the paint and is readily visible to the naked eye. It is recommended that brake discs with singular or multiple cracks, totaling 2.00 inches (or more) in length, be replaced immediately. Crack lengths totaling less than 2.00 inches should be replaced within the next 10 hours. If replacement is necessary, use brake disc P/N 164-05006 (one-piece forging).

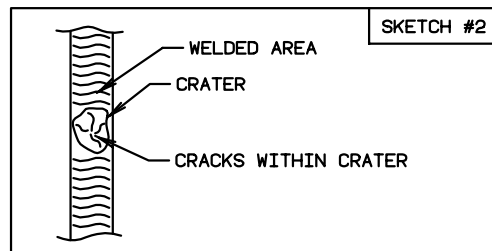
2. A slight impression or crater may be found in the weld bead (see Sketch #2). This crater is caused by electrode removal at the end of the welding cycle. Small cracks contained within this crater are not detrimental and do not necessitate brake disc removal.

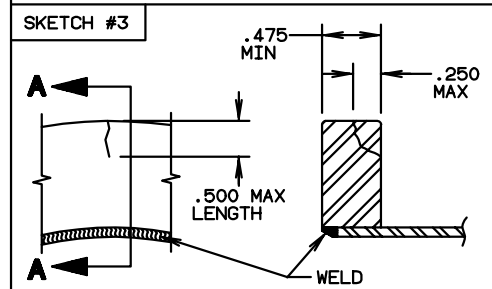
3. Heat relief cracks occasionally occur on the rubbing surfaces of the brake disc. Inspect for the following type of crack:
 - a. Crack emanates from the flange OD, such that depth can be measured. Replace disc when length of any one crack exceeds .500 inch or depth of crack exceeds .250 inch (see Sketch #3).

Discs with cracks exceeding the above limits should be replaced within the next 25 hours. Replace with P/N 164-05006 brake disc.

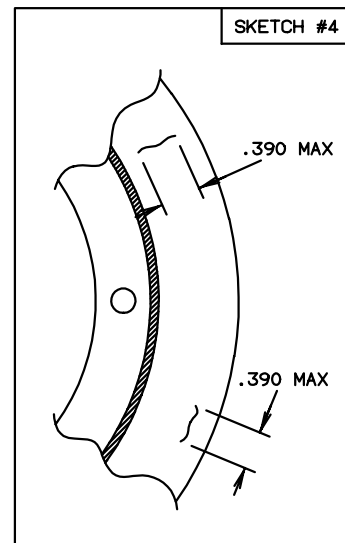
- b. Crack occurs near the center of the disc and depth is not measurable. This type of crack may be either radial or tangential in direction. Replace disc when length of any one crack exceeds .390 inch (see Sketch #4).
