## STRESS ANALYSIS OF THE PZL M28'S AIRFRAME SUBJECTED TO REPAIRS DURING FATIGUE TESTS

*Polskie Zakłady Lotnicze Sp. z o.o., ul. Wojska Polskiego 3, 39-300 Mielec*

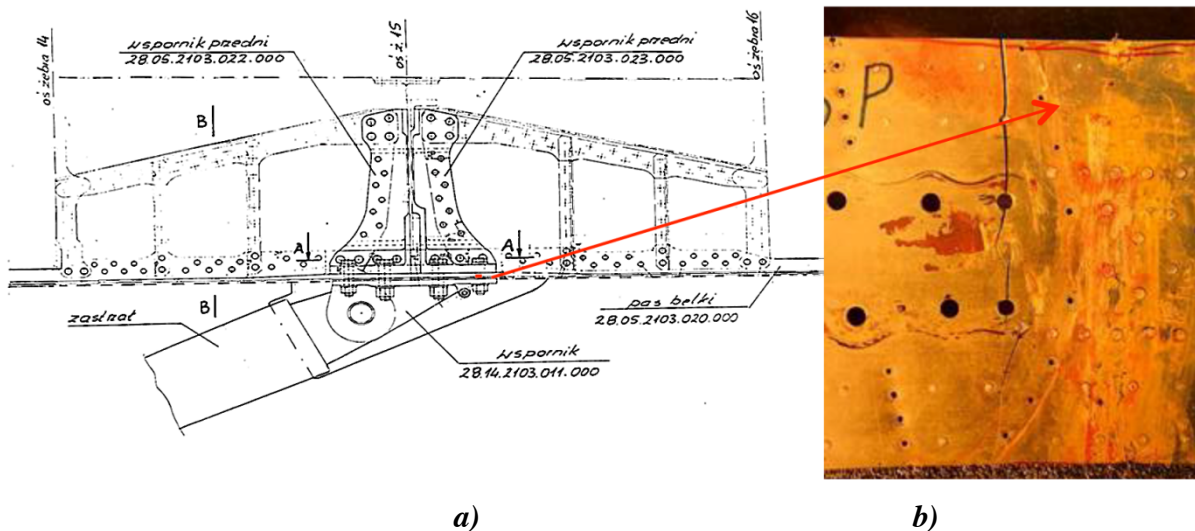
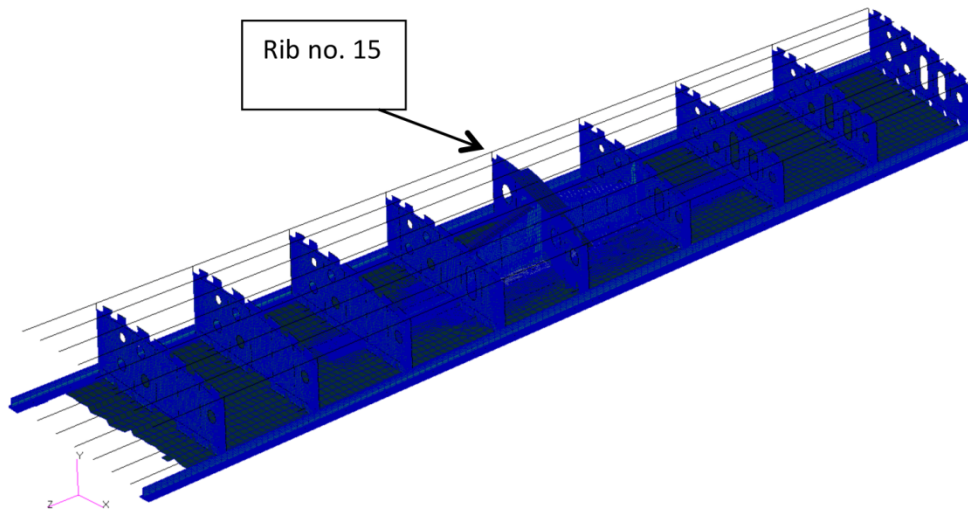
The first significant event in the test was a crack in the wing, in the area where wing strut loads are introduced at the rib 15. The crack was caused by the fatigue damage of the wing in the area of the local stress concentration (holes for bolts in the wing strut fitting mounting). The test was terminated before the damage of the tested wing could spread – see Fig. 1. The subsequent analysis showed that it was possible to repair the critical wing area on the airplane in operation, and in this way significantly extend the airplane's service life. A careful stress analysis was performed for the PZL M28's outer wing, in which the most interesting area was the rib 15, where the wing strut loads were introduced. A detailed FEM model covers the wing area from rib 10 (the root rib of the outer wing, with four fittings of the junction with the centerwing) to the rib 19 – see Fig. 1(c) and Fig. 2.

**Fig. 1. PZL M28 wing area of rib 15:**  
**(a) Sketch of the area of rib 15 with a crack indicated**  
**(b) Cracked wing skin after removal of a wing strut fitting**  
**(c) The FEM model of the wing, general view**

The wing area aft of the rib 19 was modeled as a beam. Design changes implemented in the structural beam lying between the front and rear wingspans considerably increased the service life of the wing. These changes can be introduced to the wing taken from the airplane in operation during the repair process.

The fatigue test was continued after the repair of the wing critical area, with separate design solutions implemented in the LH outer wing and the RH outer wing. This resulted in increasing the test scatter factor for the wing, according to the advisory literature recognized by the Authorities as FAA or EASA [2].

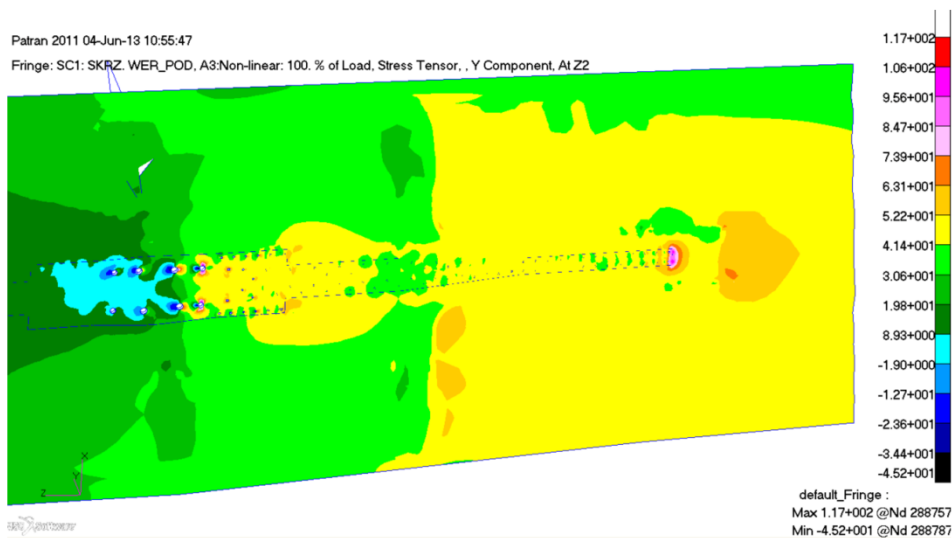
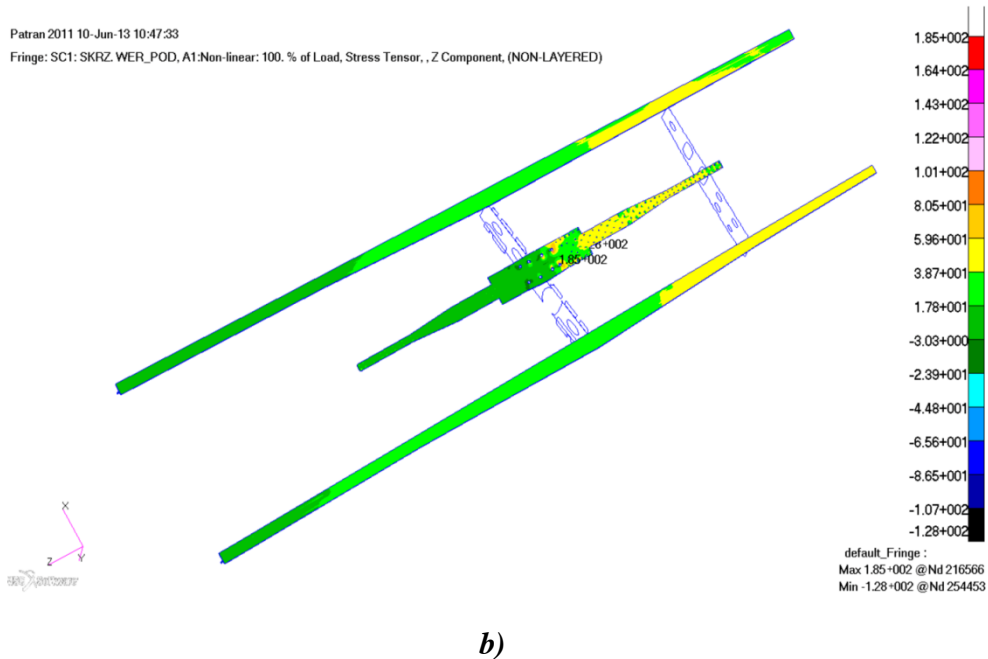
**Fig. 2. Stress distribution in the PZL M28 critical wing area according to the FEM analysis at a maximum load level during the fatigue test:**

- (a) Stress in the lower skin critical area
- (b) Stress in the wing spars' lower caps and the beam's lower cap
