A**RALLYE**

N° 120

CR 27-13

SUBJECT : Location of the rudder control on the rudder pedals.
Replacement of the rod nut by a guide nut.

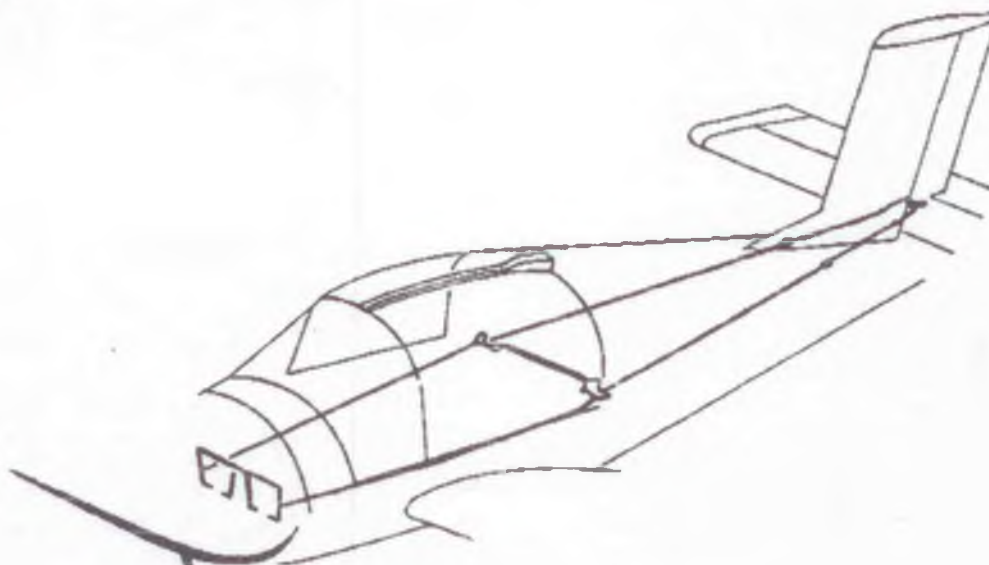
AVANT
(BEFORE)

On the other hand, at the time of overhaul or maintenance operations, some unusual manoeuvres can create abnormal buckling stresses on the rods (for example : the manoeuvre which would consist in pulling one rudder pedal while the other is maintained unmoved). This buckling may, in borderline cases, cause the failure of the rod in its threaded area, behind the eye bolt which ensures the attachment with the rudder pedal. A few similar incidents having occur, we have provided a safety device which consists in replacing the nut, item 1, by a guide nut, item 2. (see figure on page 2/3). This guide nut which has an important length and is bored at its ends, forms a bushing which is engaged both on the eye bolt tail (previously undercut) and on the plain length of the rod. This prevents any bending in this area.

Although the incidents are caused by anomalies and never occur in normal utilization, we recommend the users to replace the existing nut by the above mentioned guide nut. During this operation, it is obligatory to make sure that the rod is not distorted in its threaded area and that the thread is not damaged. (one of these two anomalies involving to reject the rod). This operation must be followed by a checking of the rudder deflexion.
