# SERVICE BULLETIN

## WHEEL ASSEMBLY 40-90 AND 40-90B – 164-02201 BRAKE DISC- INSPECT/REPLACE

- EFFECTIVITY:** Parker Hannifin 6-inch main wheel assembly Model Numbers 40-90 and 40-90B, which are equipped with Brake Disc P/N 164-02201
- APPLICABILITY:** The above listed products have been furnished for use on the following Aircraft:  
Aerospatiale / Socata TB30 Epsilon  
Grumman American GA-7  
Pilatus Britten Norman Ltd. BN-2, BN-2A, BN-2B, BN-2T  
Piper PA-24-400, PA-30, PA-32-260, PA-32-300, PA-34-200, PA-39

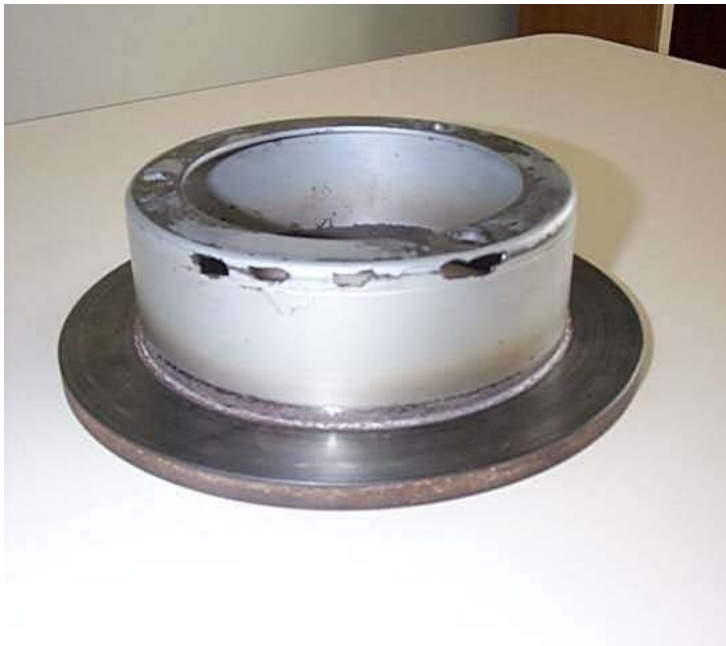
Figure 1

- In addition, products may have been used on kit planes, homebuilt aircraft or by float manufacturers.
- REASON:** Parker Hannifin has received reports of surface discontinuities in the brake disc cup wall adjacent to the mounting flange on P/N 164-02201 brake disc that have been removed from service. The returned products contain through wall discontinuities, missing material, and / or complete separation of the brake disc cup mounting surface from the brake disc cup wall and flange. (Reference Figure 1) It is required that in service products containing indications be removed from service. Continued use of a product with indications could result in the loss of directional control or brake effectiveness during taxi.

- 2) Aircraft that have been identified as not being equipped with affected products may be returned to service.
- 3) For aircraft that are identified as being equipped with affected products, remove each main wheel from the aircraft, disassemble (to the extent necessary), replace or thoroughly inspect each brake disc in accordance with the Cleveland Wheels & Brakes Component Maintenance Manual [Ref: Section 300, Para's 3.A.(1), 3.B.(1), and 3.C.(7)]. In the event that a brake disc has crack like indications, it must be replaced or more thoroughly evaluated using dye penetrant and or magnetic particle inspection techniques. These inspection techniques are more conclusive by the removal of any protective primers and paints.

- 4) Brake discs that are determined to contain cracks, worn below minimum flange thickness, elongated bolt holes, excessively coned or corroded must be replaced.
